# UNITED FIRST PARISH CHURCH (UNITARIAN)

Quincy, Massachusetts

**HISTORIC STRUCTURE REPORT**

April 1996

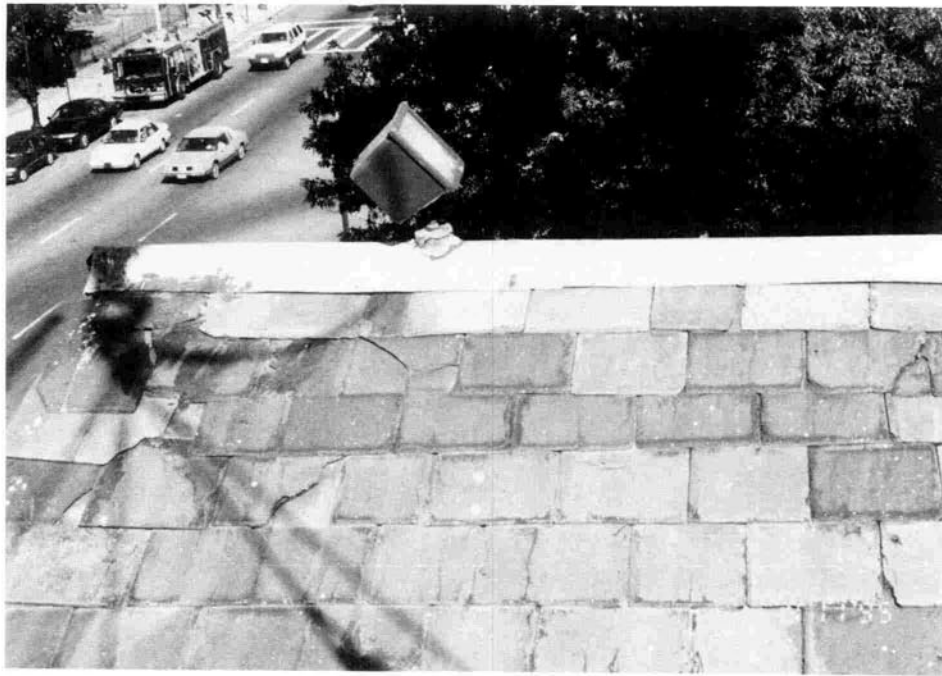
**Figure 67.** Tower exterior: west portico, slate roof with copper ridge cap. Note cracked and repaired slates, bituminous patches, loose copper flashing, and spotlight screwed to ridge cap.

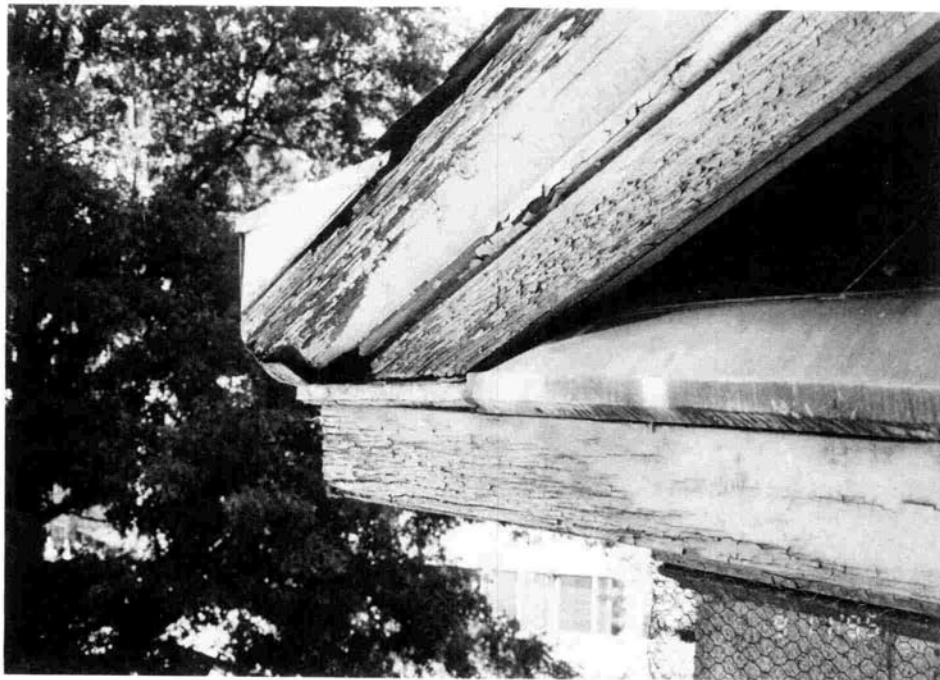
**Figure 68.** Tower exterior: west portico, north end of entablature. Note peeling paint, cracked moldings, open joints, and granite stains from rusting chicken wire.

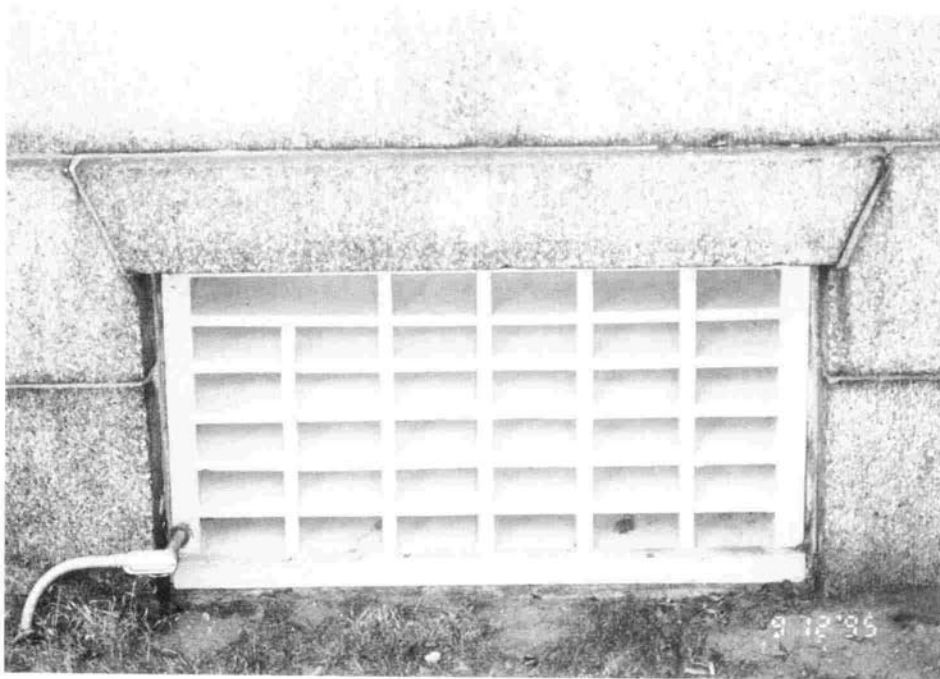
**Figure 89.** Church exterior: north wall, basement window (W016), showing sash replaced with metal furnace room ventilation panel. Note that grade is above sill level.

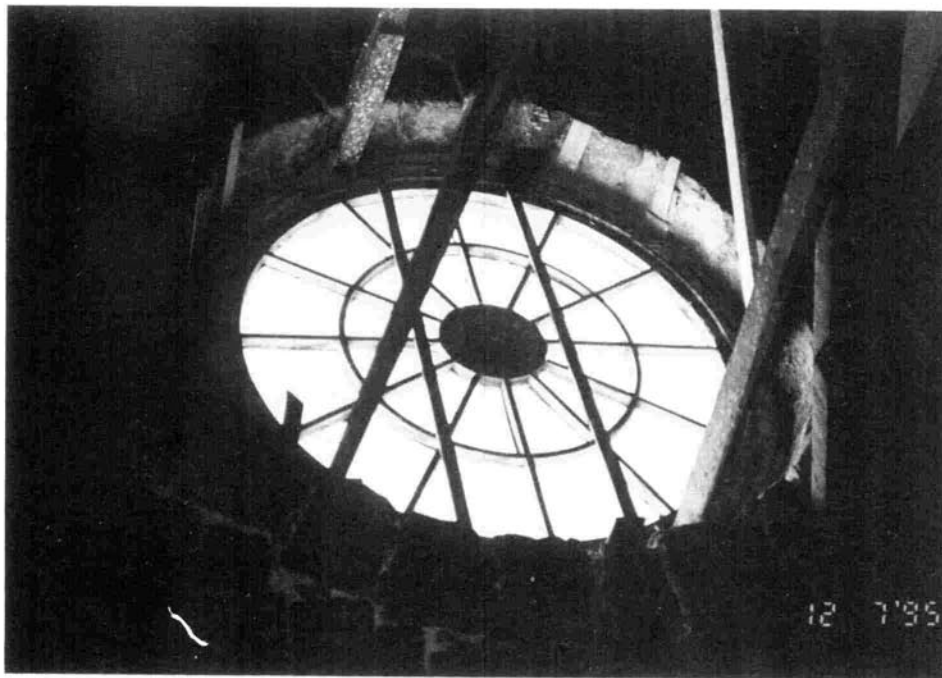
**Figure 90.** Church exterior: east wall, attic oculus (W302), with loose glazing, peeling paint, open joints; now covered with an exterior thermoplastic sheet.

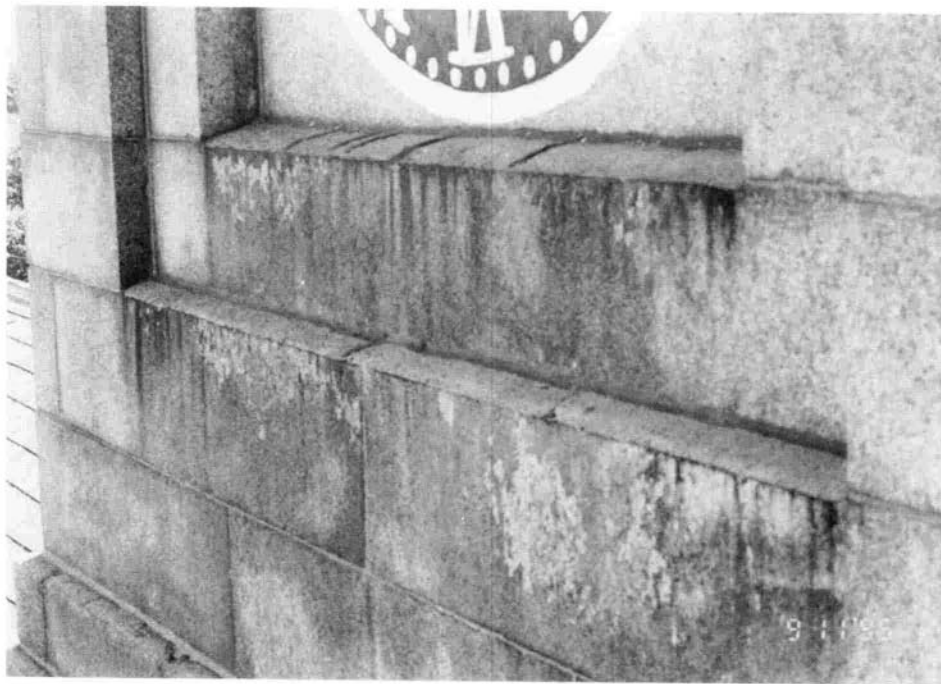
**Figure 95.** Tower exterior: shaft, east side with glazed clock face. Note open joints and stained granite, and spotlight attached to copper ridge cap.

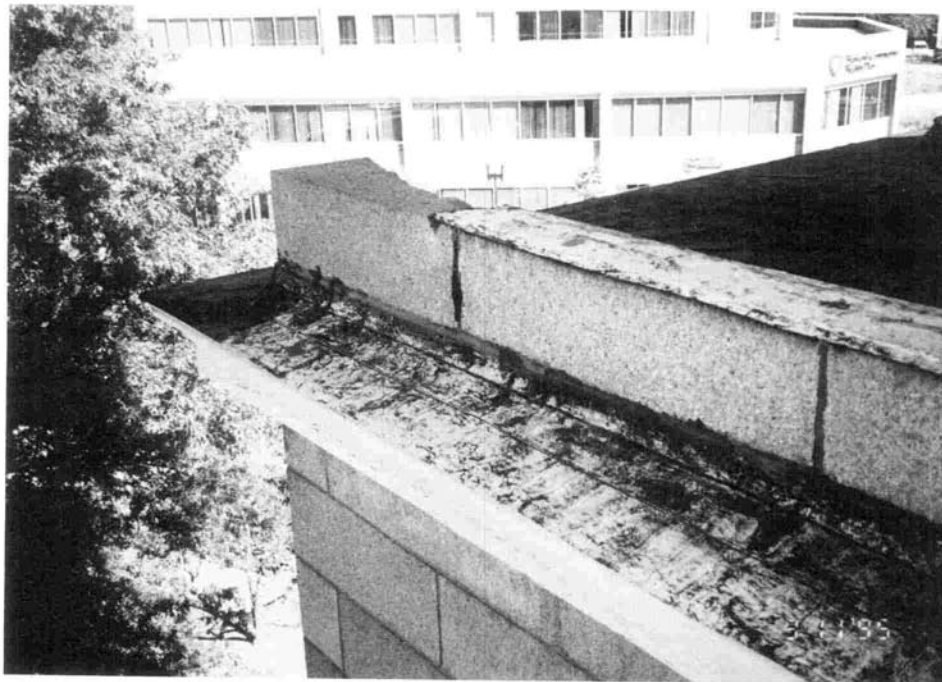
**Figure 98.** Tower exterior: base, north end of west parapet. Note inappropriate use of bituminous asphalt to seal masonry joints and to parch the copper flat-seam roof; flashing is missing from parapet wall.

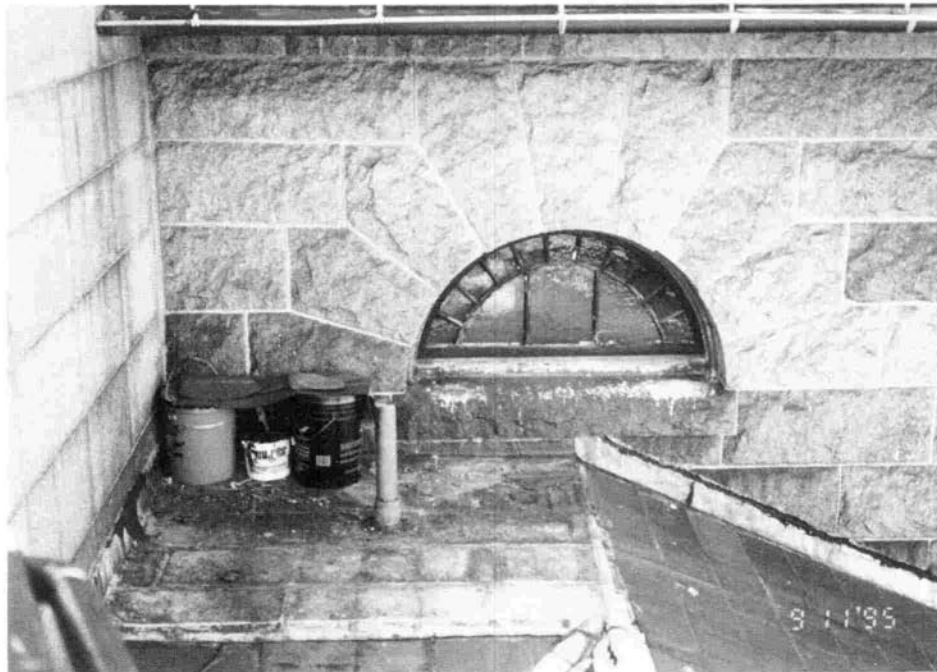
**Figure 99.** Addition exterior: intersection of south wall with church, showing roof of south wing and lunette window. Note surplus supplies left after last repair with bituminous asphalt; window has peeling paint and dry wooden components.

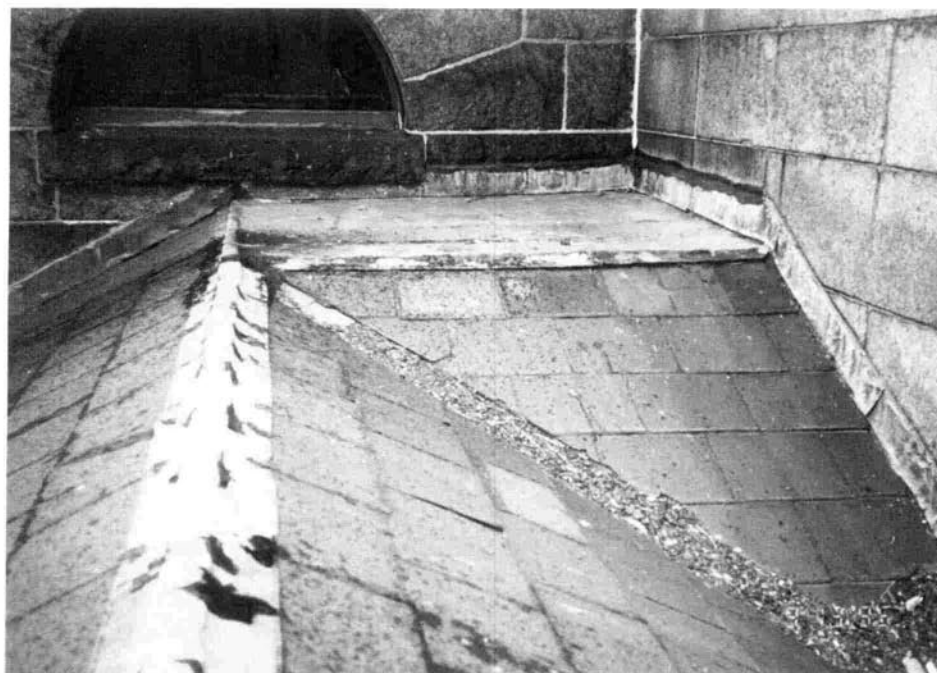
**Figure 100.** Addition exterior: intersection of north wall with church, showing roof of north porch and lunette window. Note bituminous patches on copper ridge cap and slate roof, clogged valleys, and peeling paint and open joints of window.

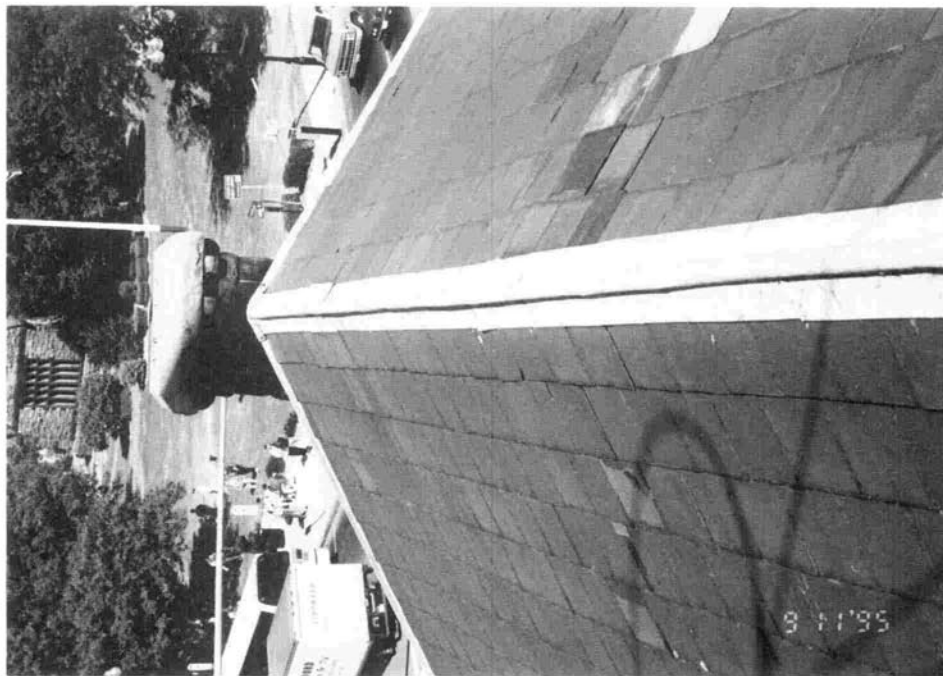
**Figure 101.** Addition exterior: slate roof and copper ridge cap, view eastward. Note replacement shingles, rolled copper ridge cap, and granite chimney.

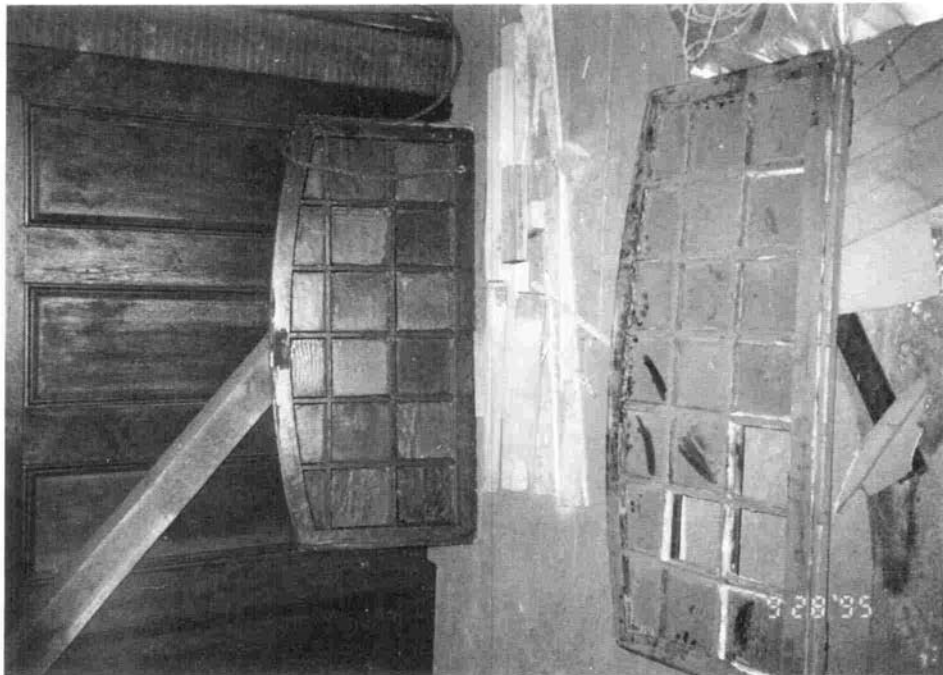
**Figure 102.** Sashes of south eyebrow window (W201) and north eyebrow window (W203), stored in attic. Note peeling paint and missing ribbed, colored glass.

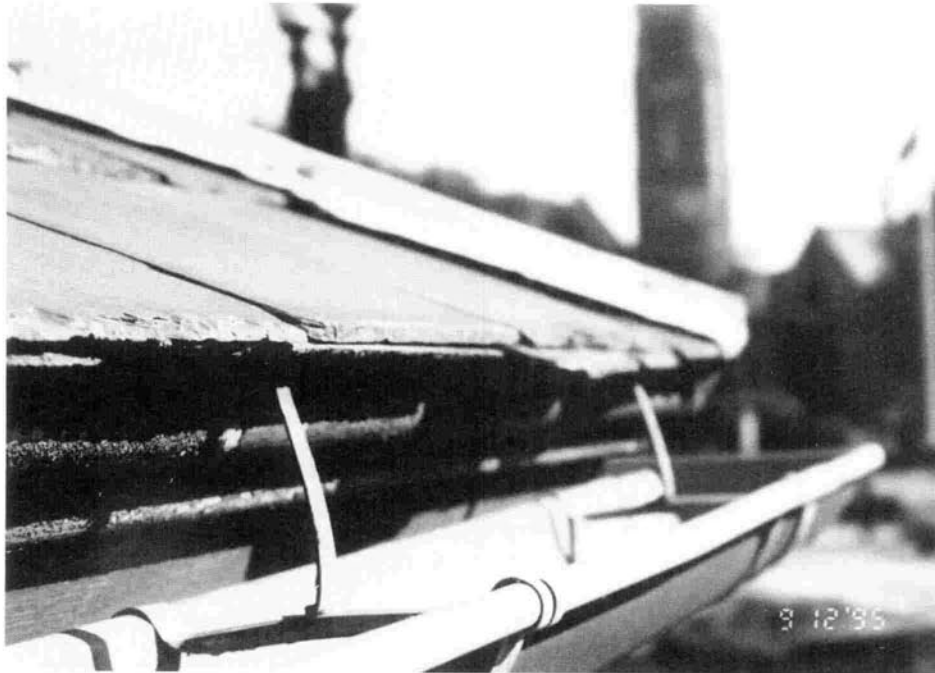
**Figure 103.** Addition exterior: east end of south half-round copper gutter and cornice. Note lifting slates and hip ridge cap, and peeling paint, dry wood, and open joints of cornice.

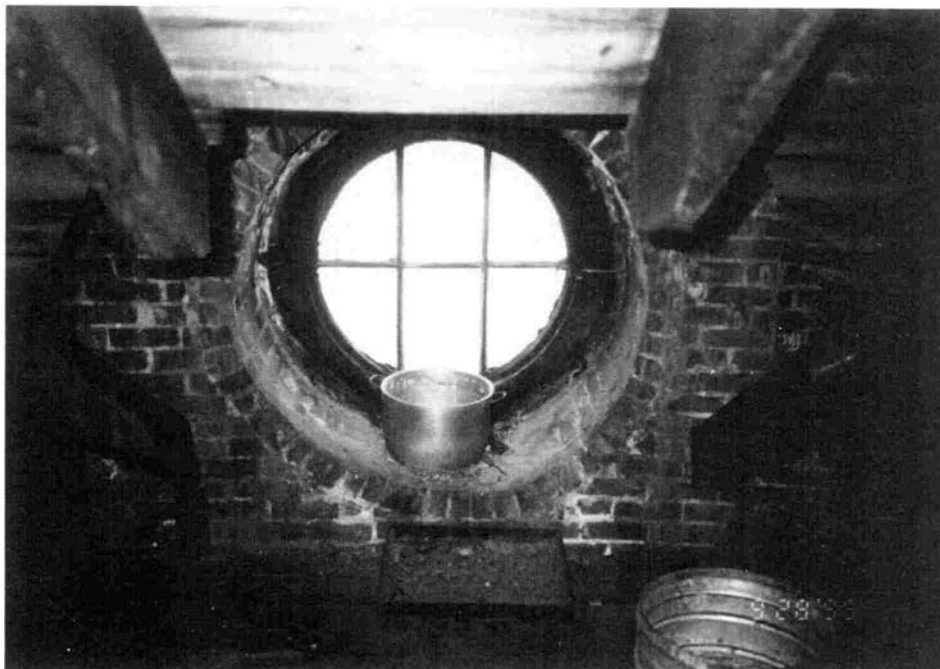
**Figure 104.** Addition interior: east wall, attic oculus (W202). Note effects of leaks through the flashing and/or the open joints of the sash and surround, and repointing of brickwork.

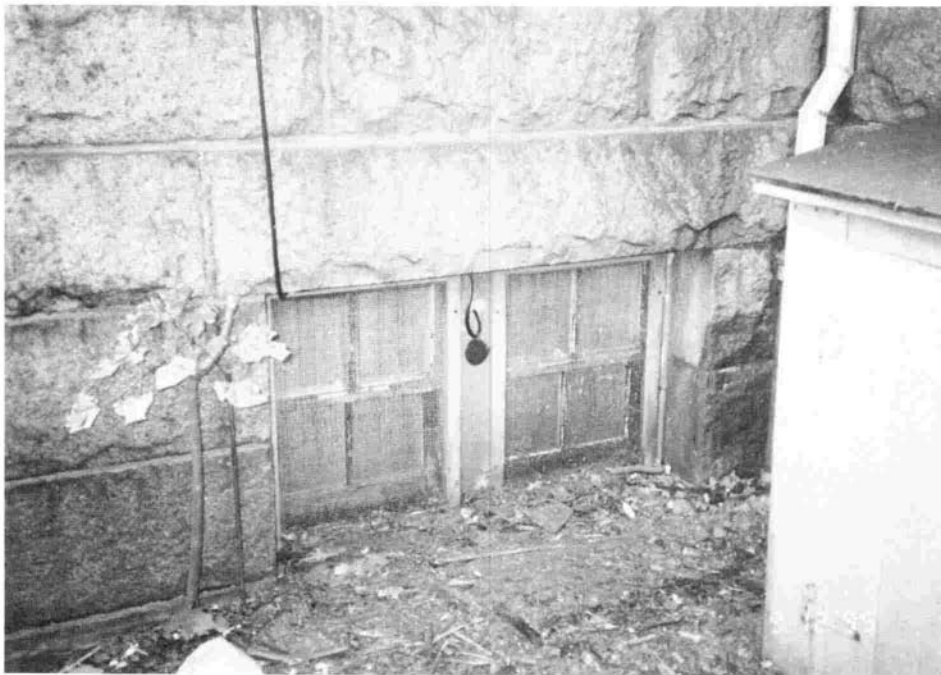
**Figure 108.** Addition exterior: north wall, basement window (W015). Note wire security mesh, soil above sill level, peeling paint, and biological growth, which affect both windows and the granite foundation.

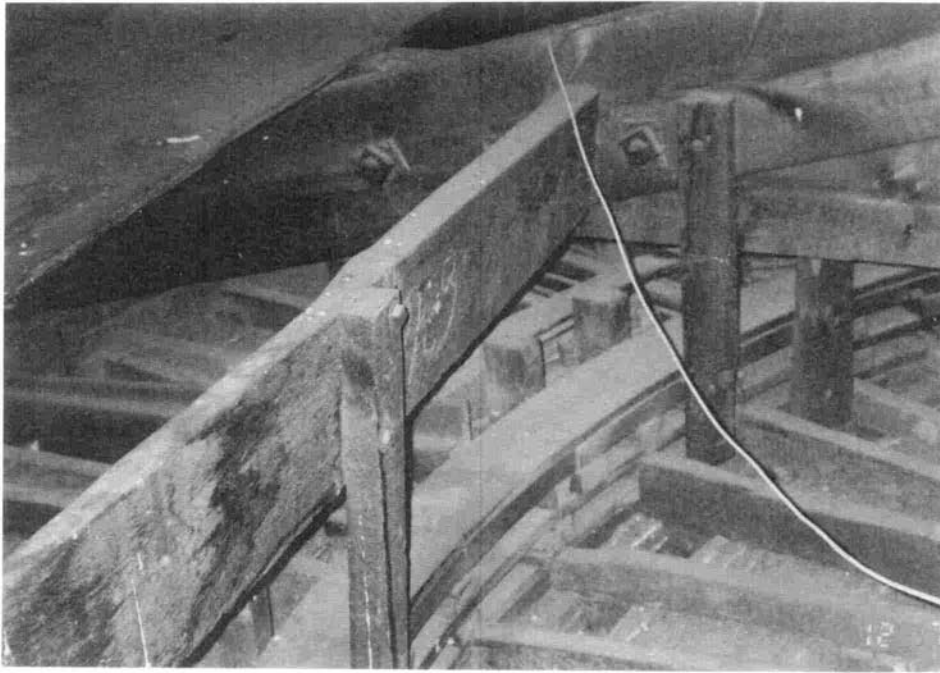
**Figure 109.** Church interior: attic, view of framing of sanctuary's coffered ceiling dome. Note scissors truss and water stains from roof leaks on many of the wooden elements.

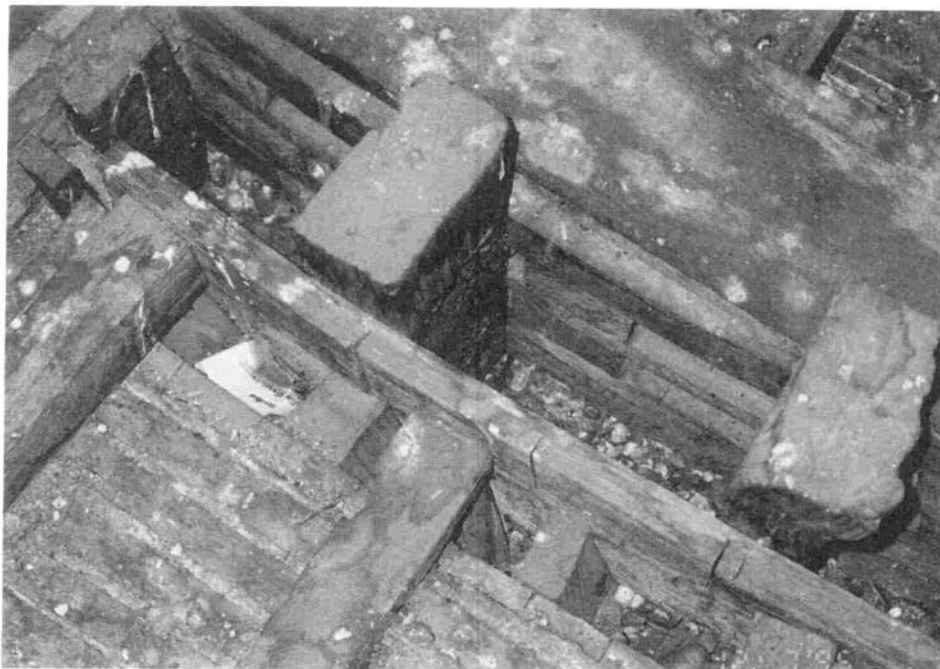
**Figure 110.** Church interior: attic, view of plaster keys of sanctuary's coffered ceiling dome. Note accumulation of debris and pigeon droppings, although bird access now seems blocked.

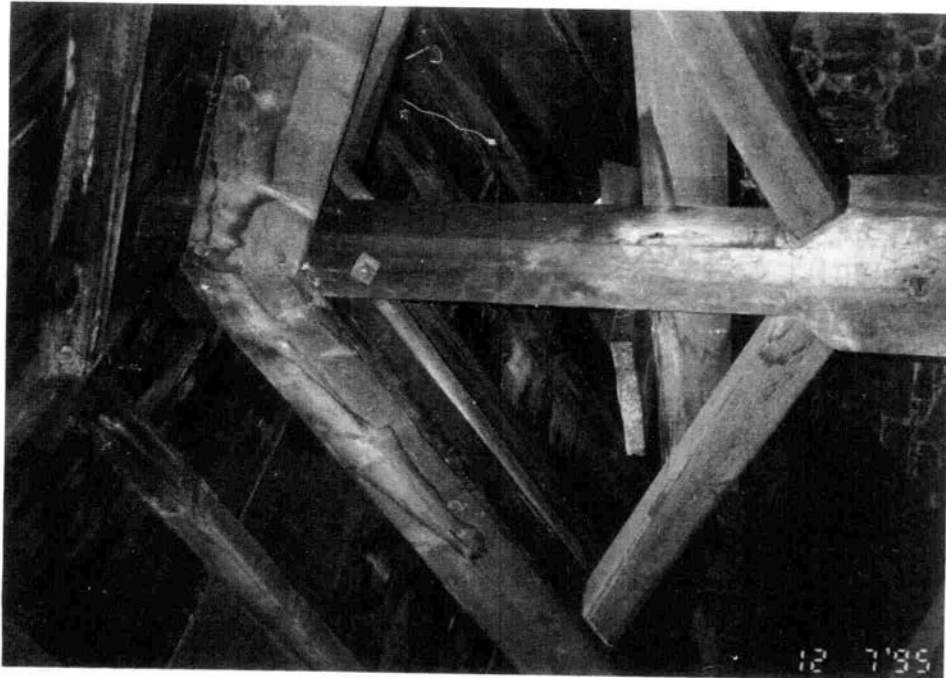
Figure 111. Church interior: attic, westward view of king post, rafter, and sheathing. Note water damage from leaks, mold growth, and rusting chicken wire.

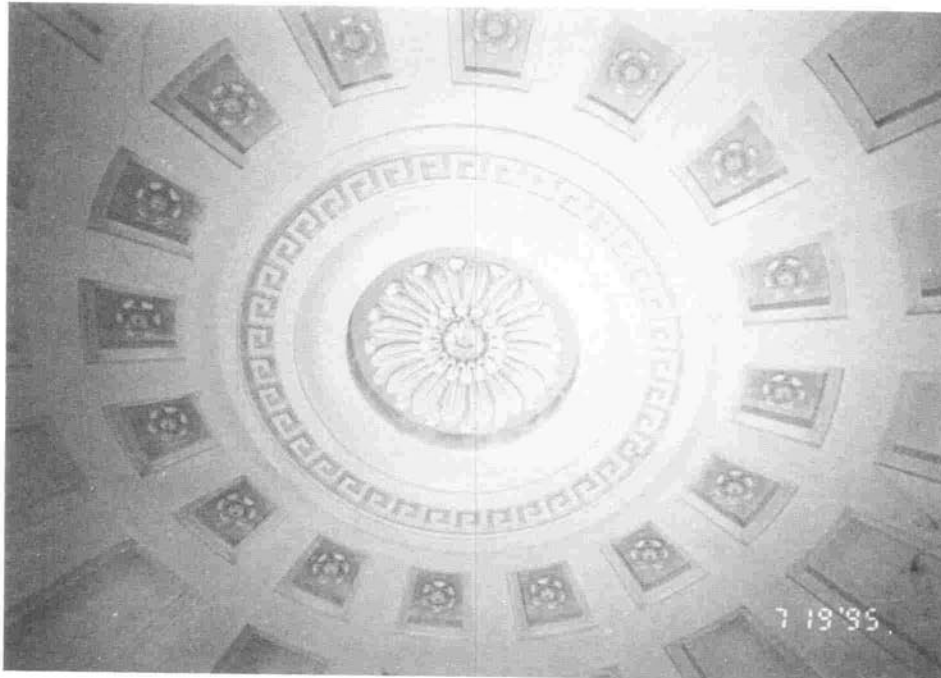
**Figure 115.** Church interior: sanctuary (Room 103), coffered dome ceiling. Note minor areas of diagonal cracks and water stains from roof leaks.

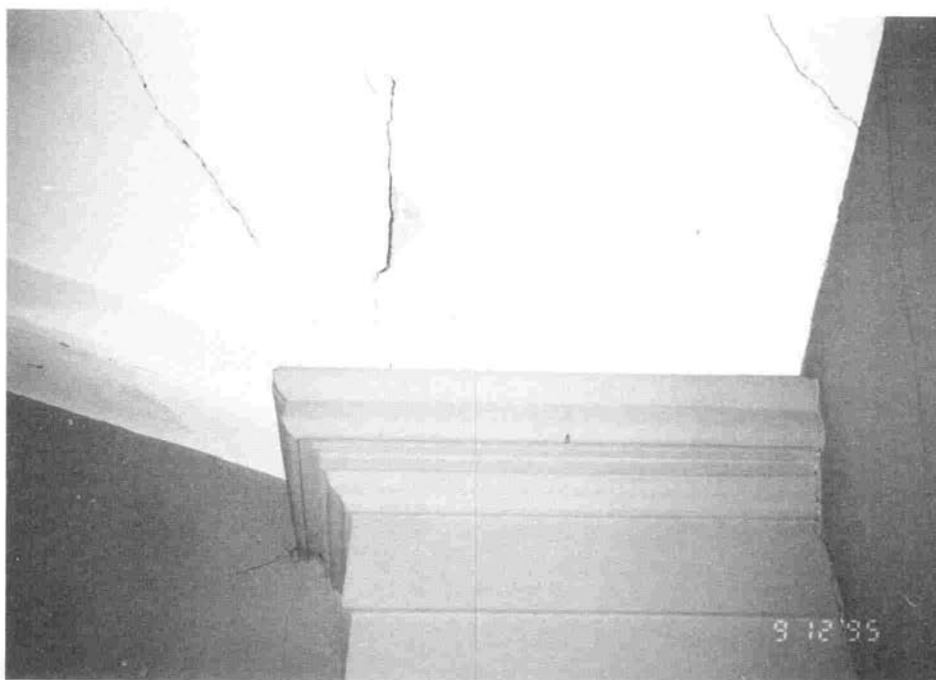
**Figure 116.** Church interior: sanctuary (Room 103), southwest corner at intersection of ceiling and wall pilaster. Note largest plaster-wall crack and water stains from leaks.

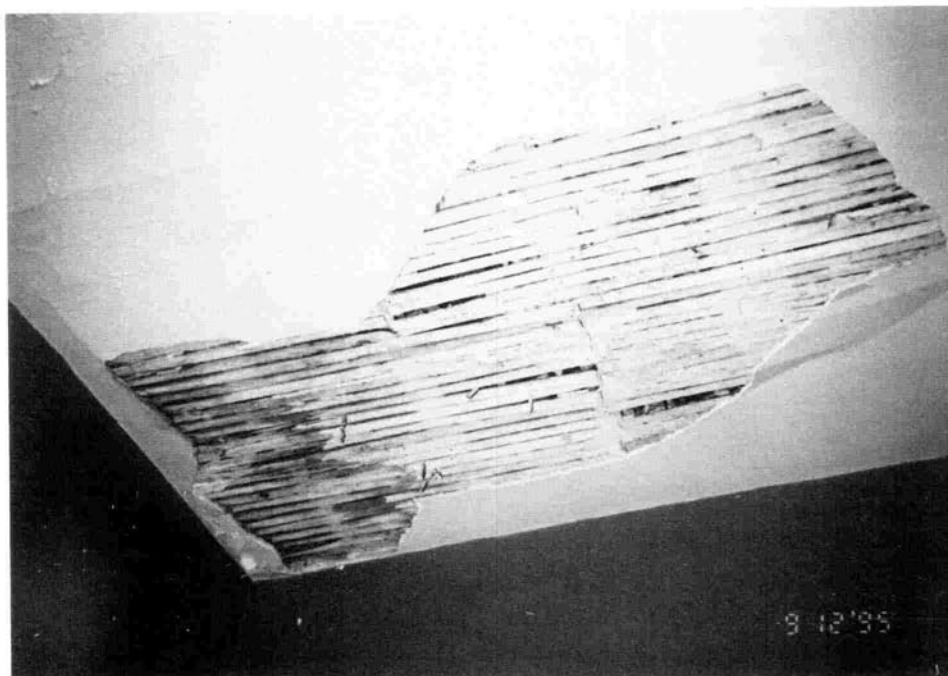
**Figure 119.** Tower interior: second-story vestibule south room (Room 202), southeast corner of ceiling where plaster has fallen due to failed plaster keys due to roof leaks.

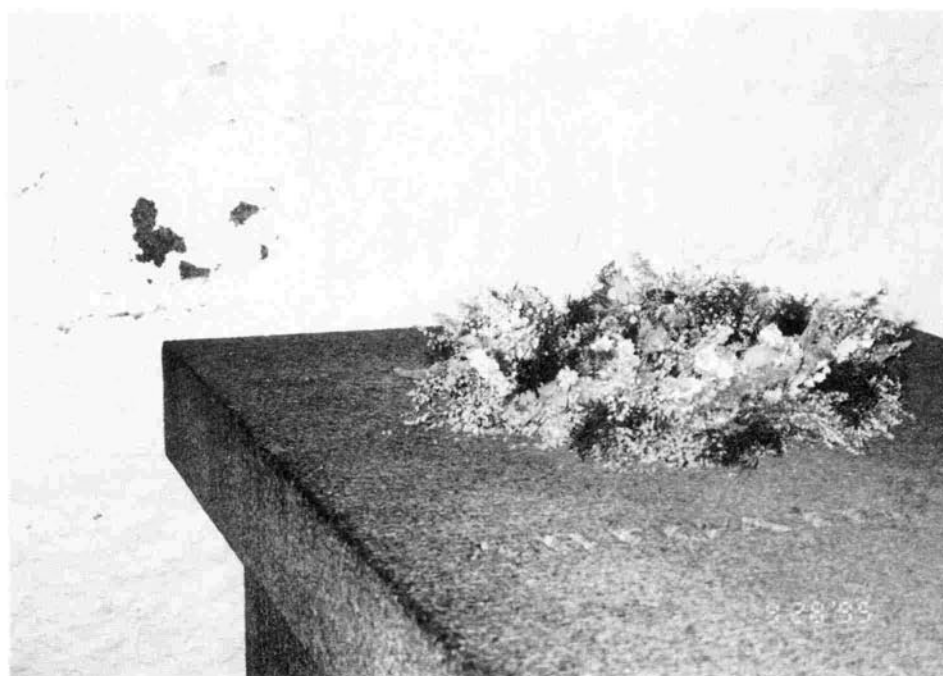
**Figure 120.** Tower interior: basement crypt south room (Room 003), west wall. Note whitewash peeling from granite wall due to moisture penetration of wall.
